United States Department of the Interior
National Park Service**National Register of Historic Places Registration Form**

1. Name of PropertyHistoric name: Double Arrow LookoutOther names/site number: 24MO0157

L-4 Lookouts on the Lolo National Forest

City or town: Seeley Lake State: Montana County: MissoulaNot For Publication: ☐ Vicinity: ☒**3. State/Federal Agency Certification**

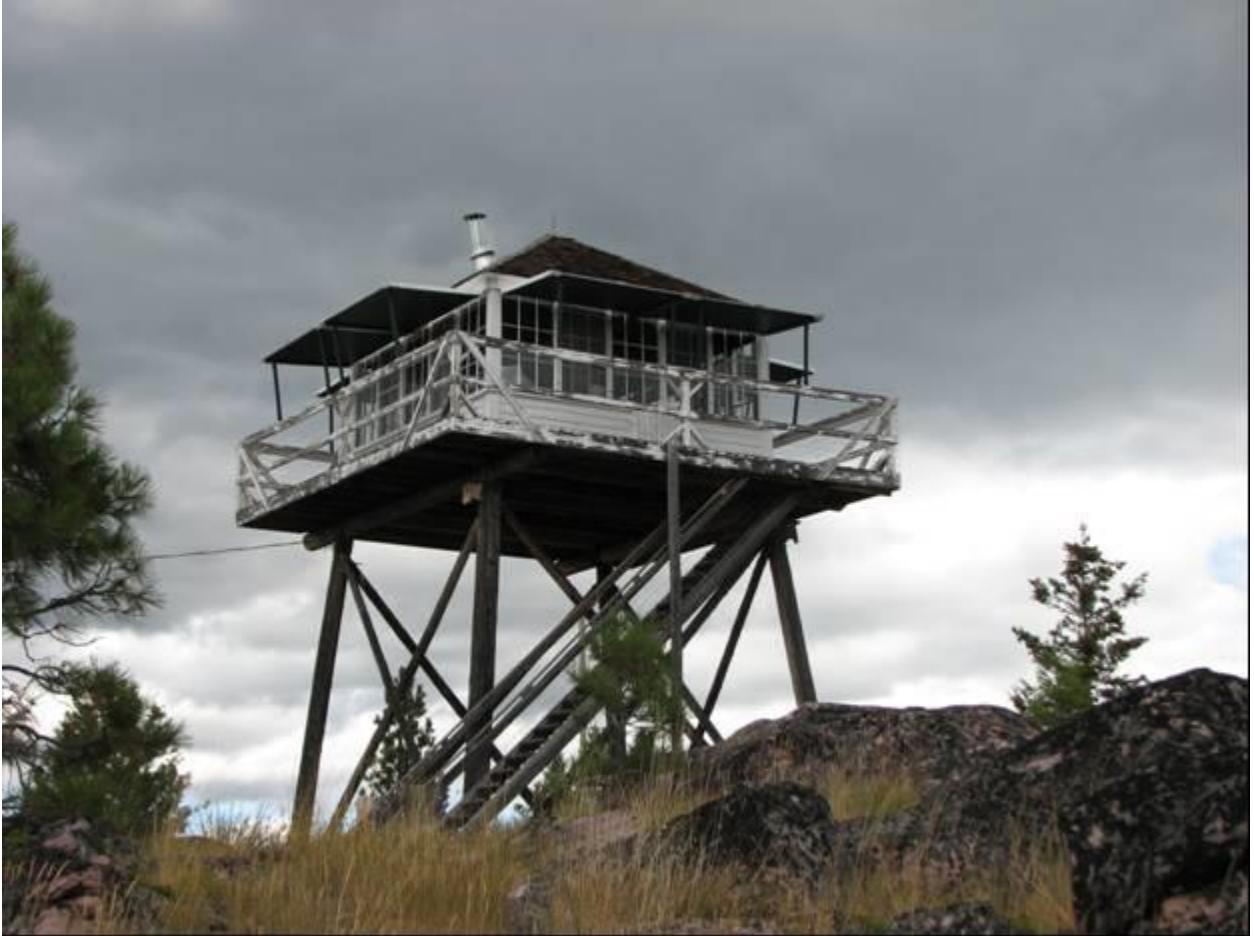
MT_MissoulaCounty_DoubleArrowLookout_0001. Looking northeast to the west and south walls of the Double Arrow Lookout.

Double Arrow Lookout (one contributing building). The Double Arrow Lookout is a 14 ft. by 14 ft. wood frame building with a pyramidal roof built atop a 20 foot-high, log tower. Simple drop wood siding covers the lower portion of the exterior walls, and the roof is covered with sawn cedar shingles.¹ A new stainless steel stove pipe extends above the west slope of the roof. The entry into the lookout house is located at the south end of the wall that faces east-northeast, and contains a wood door with six lights above a narrow panel. A ribbon of four, nine-light windows occupy the area above the lower wall north of the door. The remaining three walls each contain a ribbon of five, nine-light window units, two of which slide sideways allowing ventilation. Openings for the sliding sashes have been fitted with removable, wood-frame screens that can be attached to the exterior of the building.

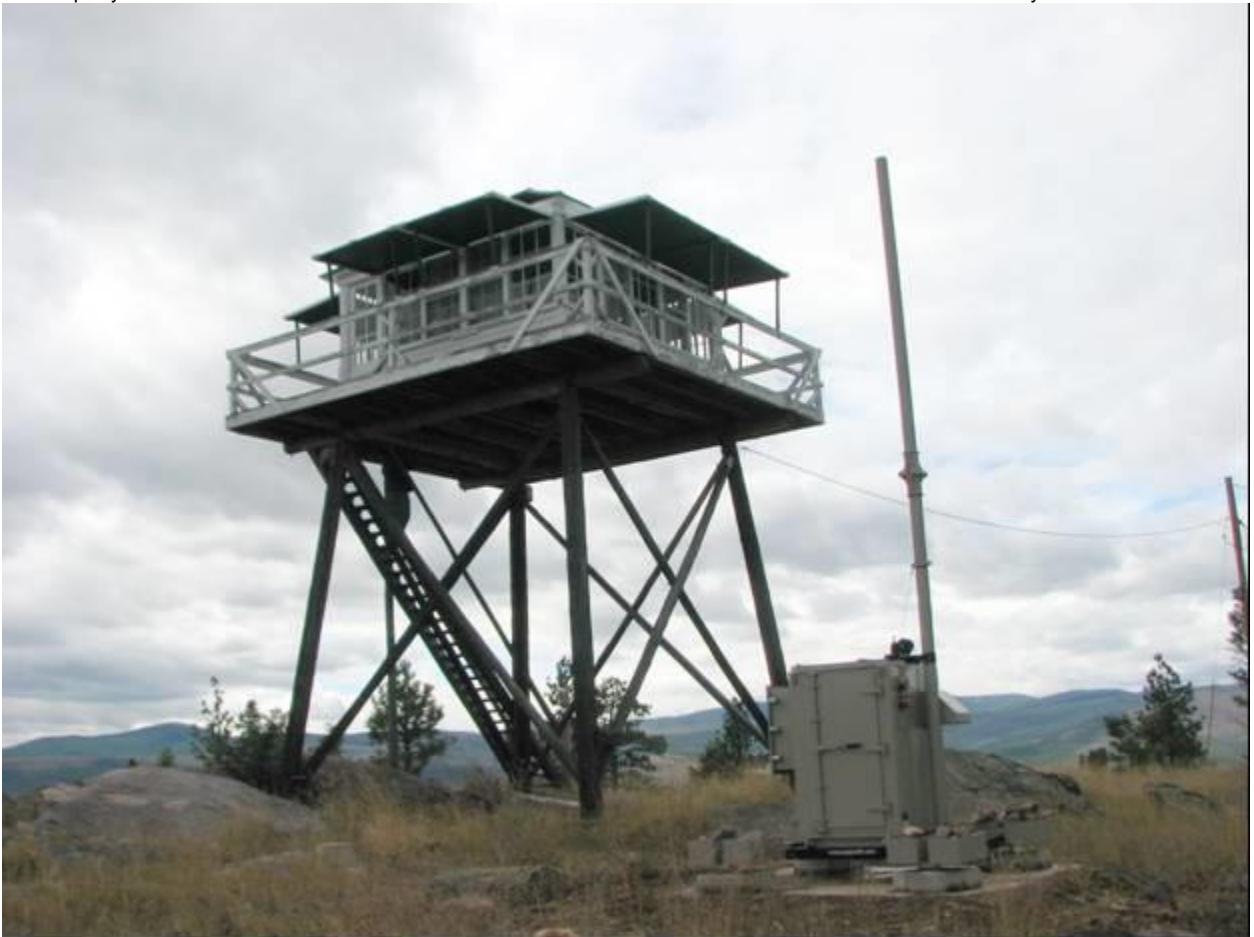
MT_MissoulaCounty_DoubleArrowLookout_0002. Looking south-southwest to the east (front) and north walls of the Double Arrow Lookout. Radio relay equipment in foreground.

Radio Equipment Box (one noncontributing structure). The steel radio equipment box stands about 4 ft. tall and measures about 2 ½ ft. square. It rests on four small concrete blocks

positioned at each corner of the box that sit on a larger 4 ft. by 4 ft. poured concrete pad; the four corner blocks elevate the box above the larger concrete pad. A metal pole that measures approximately 12 ft. in height is affixed to the north side of the box. It is unknown when the radio equipment was installed on the property.

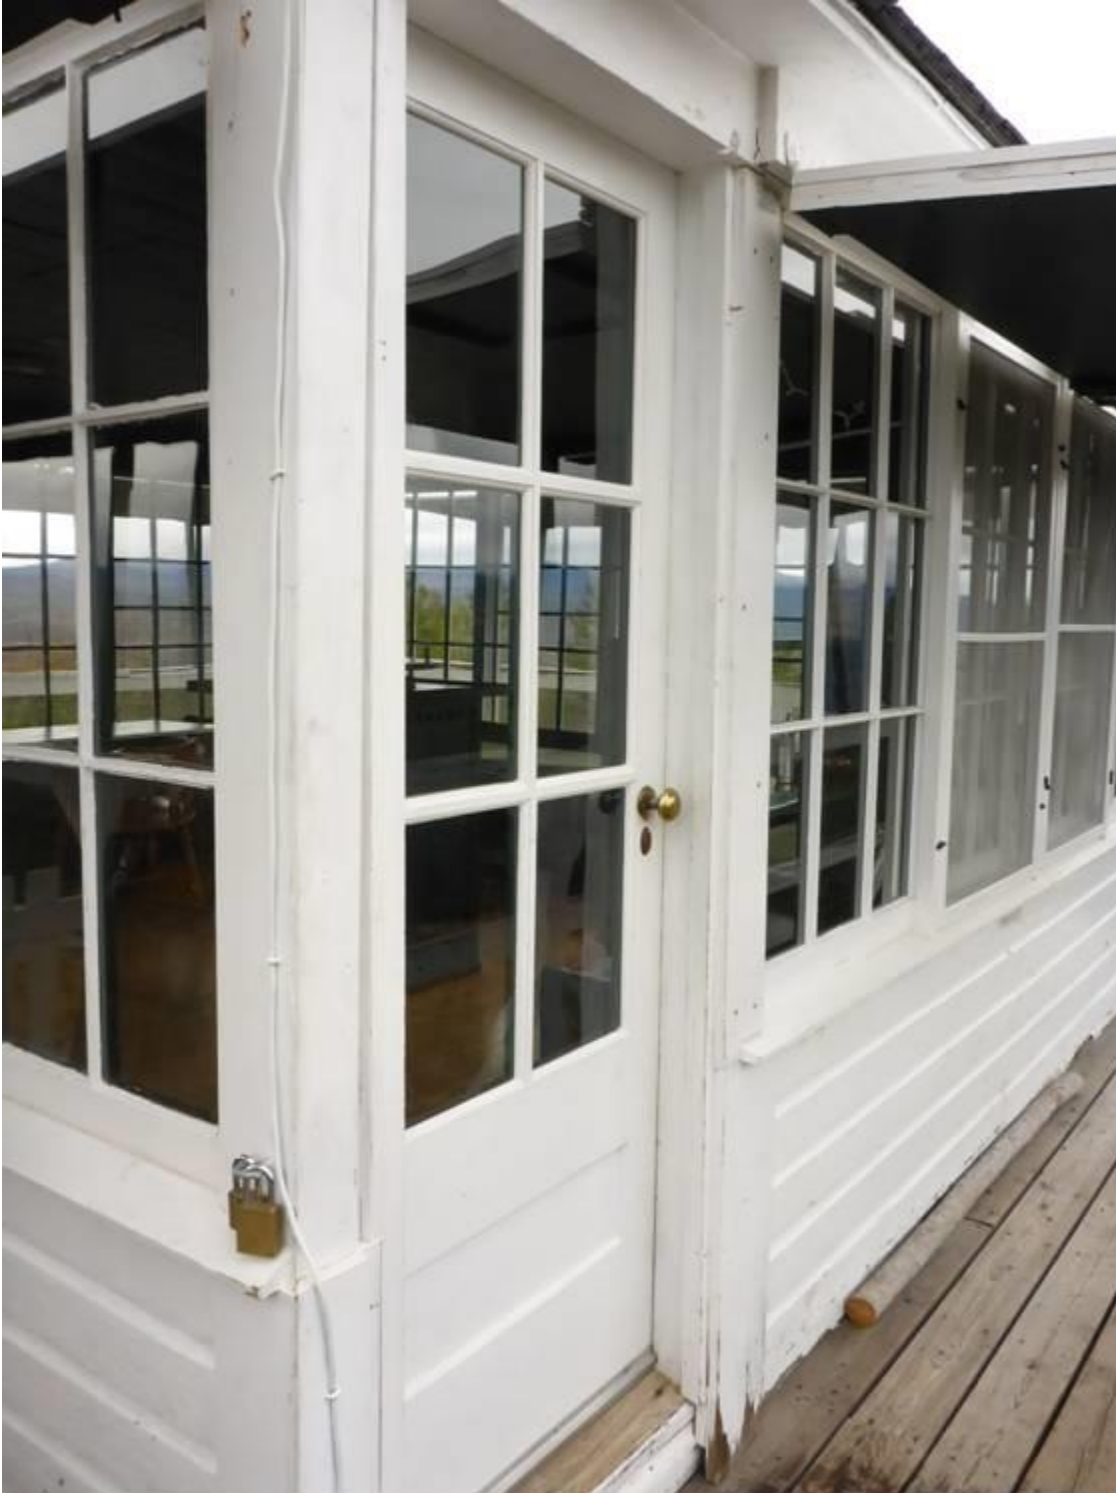
MT_MissoulaCounty_DoubleArrowLookout_0003. Detail of the door, located at the south end of the east wall.

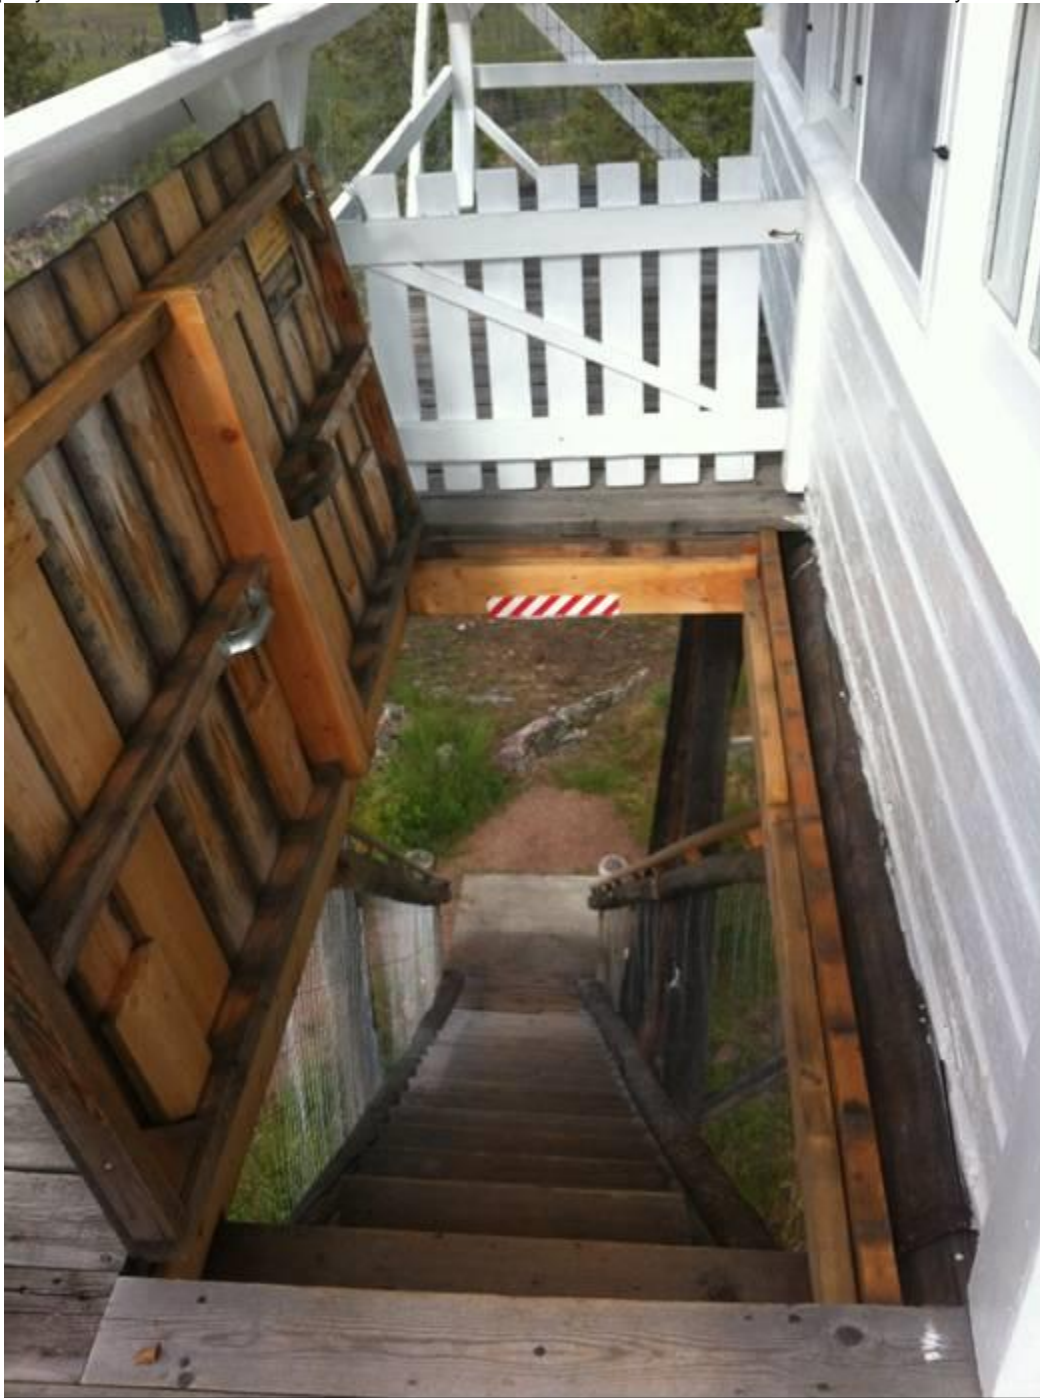
MT_MissoulaCounty_DoubleArrowLookout_0004. Looking down the stair through the open trapdoor.

The four legs of the cross-braced tower have concrete footings. A single-flight stairway leads from the southwest corner of the tower to a trapdoor in the catwalk. The stairs have log stringers and board treads. Pole handrails are located on both sides of the stairs, and wire mesh has been attached to the stringers and handrails as a safety measure. At the top of the stairs a trapdoor provides access to the catwalk. A low gate with a spring hinge is located across the catwalk at the edge of the trapdoor.² Like the stairs, wire mesh ('hog wire') has been attached to the catwalk railing as a safety measure.

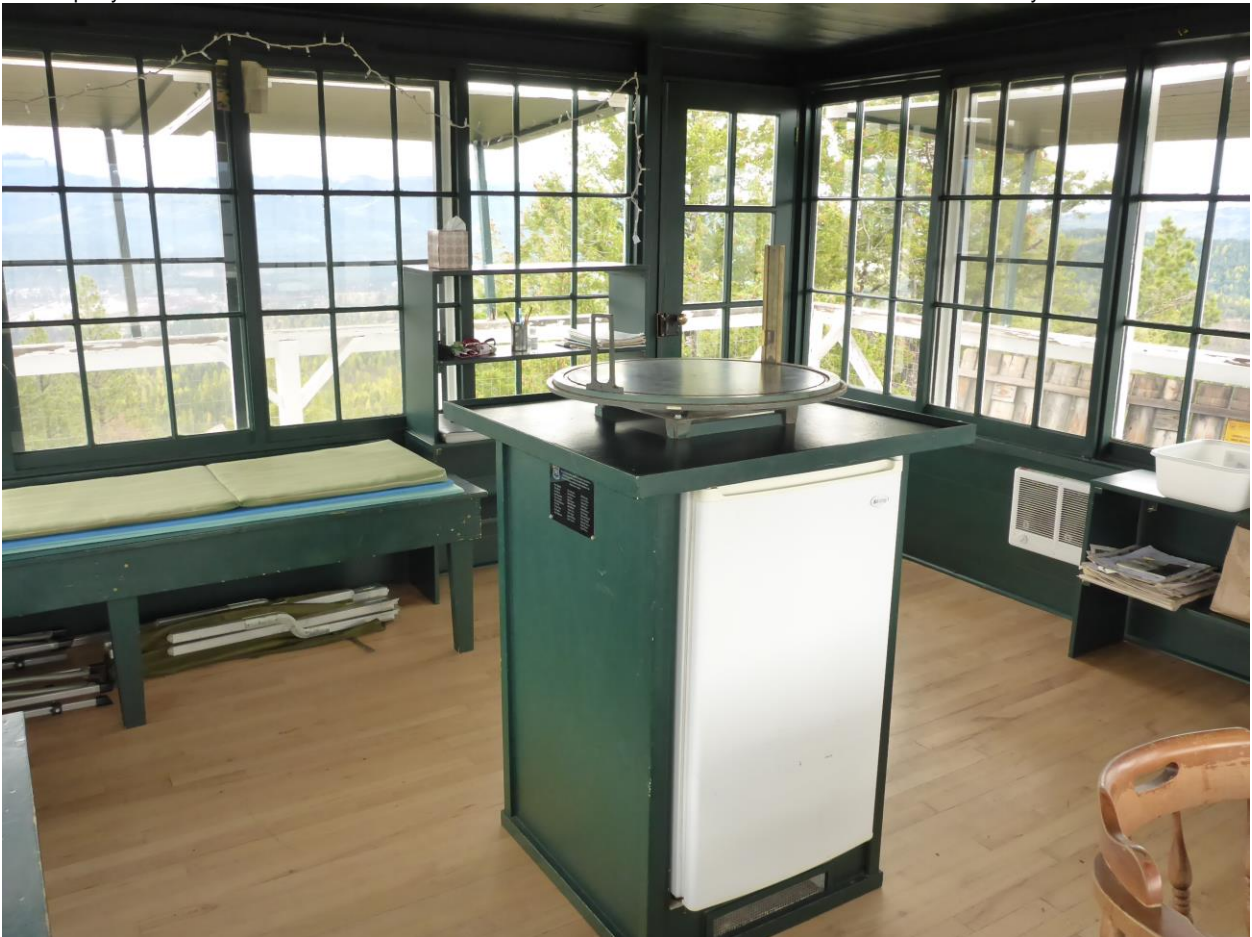
MT_MissoulaCounty_DoubleArrowLookout_0005. Interior of Double Arrow lookout house, view to east-southeast. Cabinet for refrigerator cleverly designed to look like the base for a fire-finder.

The one-room interior, designed to serve as a lookout man's quarters and work space, has few fixed elements. The original maple floor is in good condition. With the adapted reuse of the building as a cabin rental, the wood stove was removed and the building fitted with an electric wall heater. As originally built, a trap door in the ceiling led to a small storage compartment. A ceiling-mounted ladder that used to access the compartment has been removed.

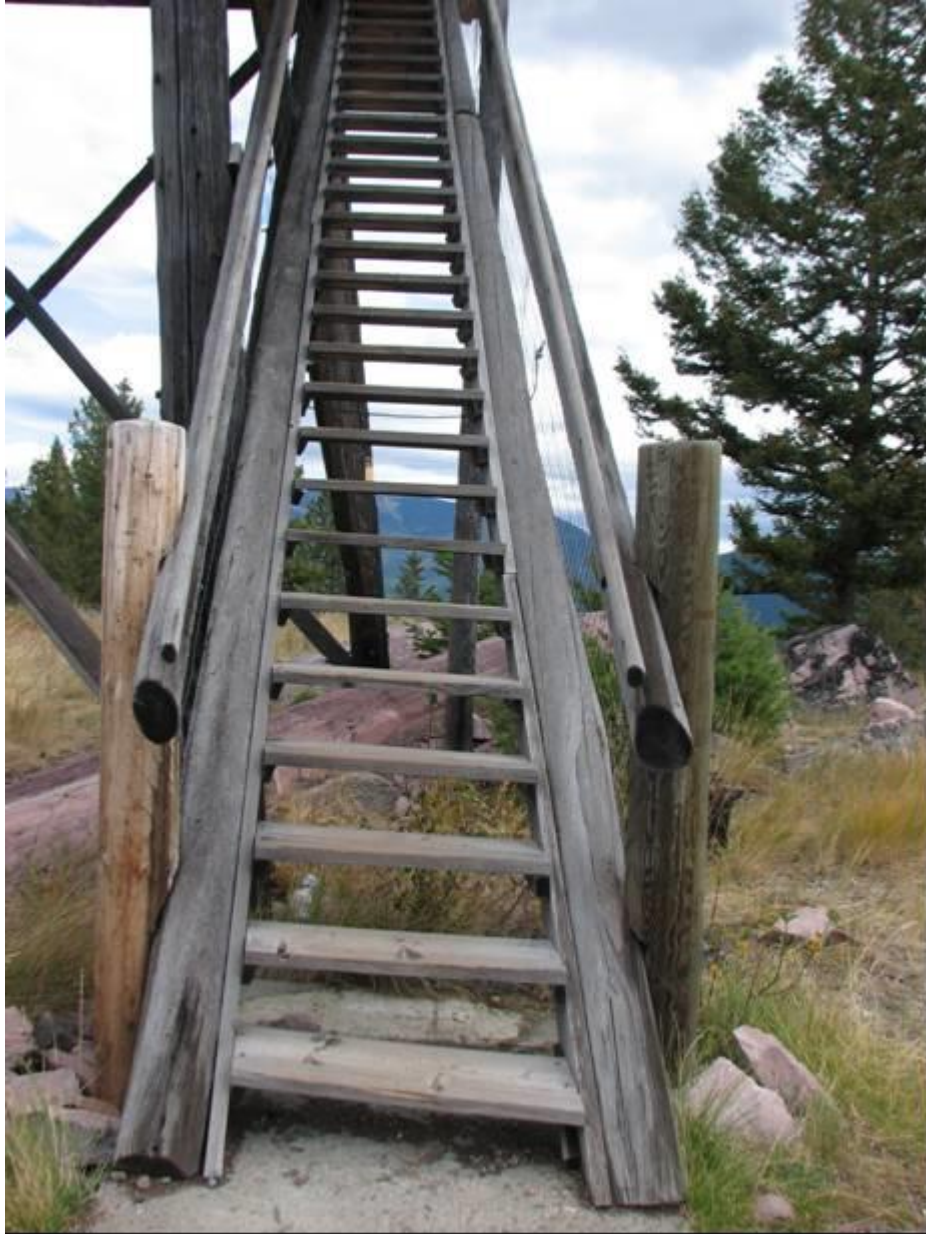
MT_MissoulaCounty_DoubleArrowLookout_0006. Looking east-northeast: detail of the log stairway.

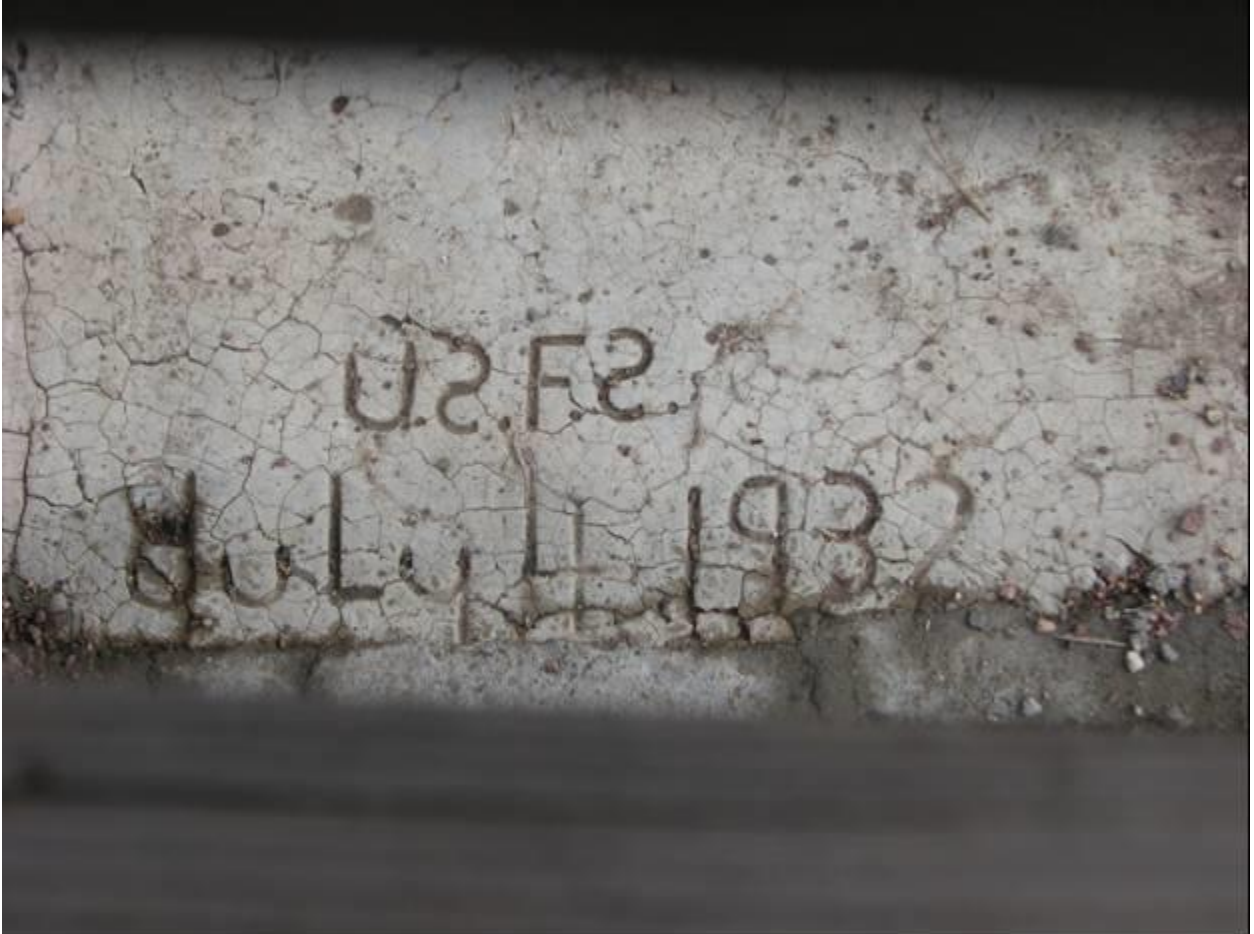
MT_MissoulaCounty_DoubleArrowLookout_0007. Detail of concrete tower base stamped with "USFS / July 4, 1932." Note the two Ss, are inverted.

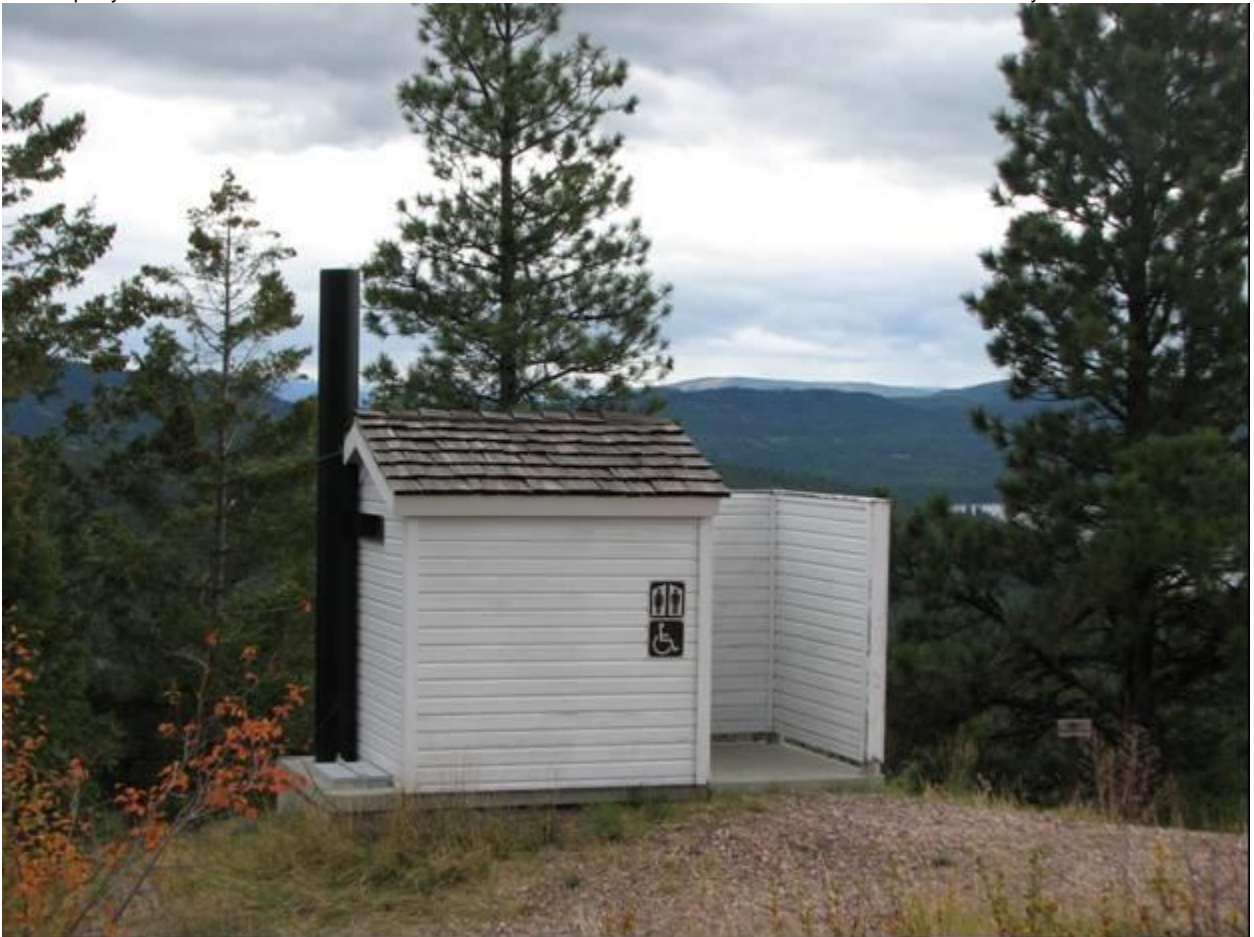
MT_MissoulaCounty_DoubleArrowLookout_0008. Looking south to the modern, noncontributing pit toilet.

Modern pit toilet (one noncontributing building). Built sometime between 1994 and 2012, the modern pit toilet, or SST (sweet smelling toilet), is located about 110 ft. southeast of the lookout tower, on the south side of the lookout spur road. It is a one-story, wood-frame building construction on top of a concrete vault. The exterior walls are covered with simple drop siding with vertical corner board trim. The front gable roof is covered with wood shingles. The entrance in the center of the southwest wall contains a metal door with one opaque light above a vent. The entrance is shielded by a two-sided, wood-frame privacy screen that extends from the front wall of the building. A large metal vent is located adjacent to the rear (northeast) wall.

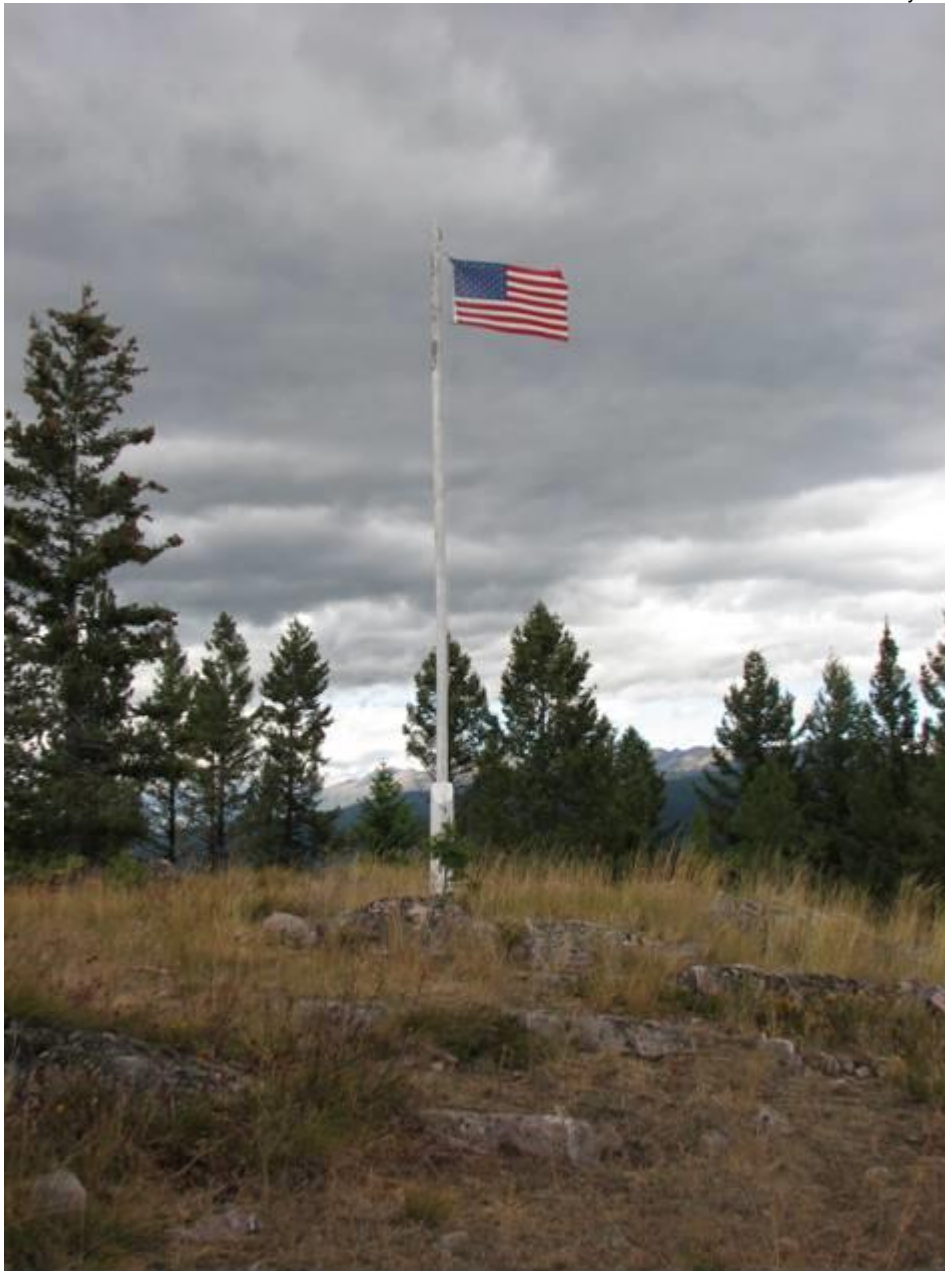
MT_MissoulaCounty_DoubleArrowLookout_0009. Looking southwest to the flagpole.

Flagpole (one contributing object). The flagpole is located about 60 ft. northeast of the lookout tower. It consists of a small diameter peeled tree (about 30 ft. long), bolted between two log supports that are partially buried. The tops of the log supports are beveled.
